# South Arkansas River Stream Health Assessment

## County Road 107 to confluence

December 18, 2020

Central Colorado Conservancy, Salida

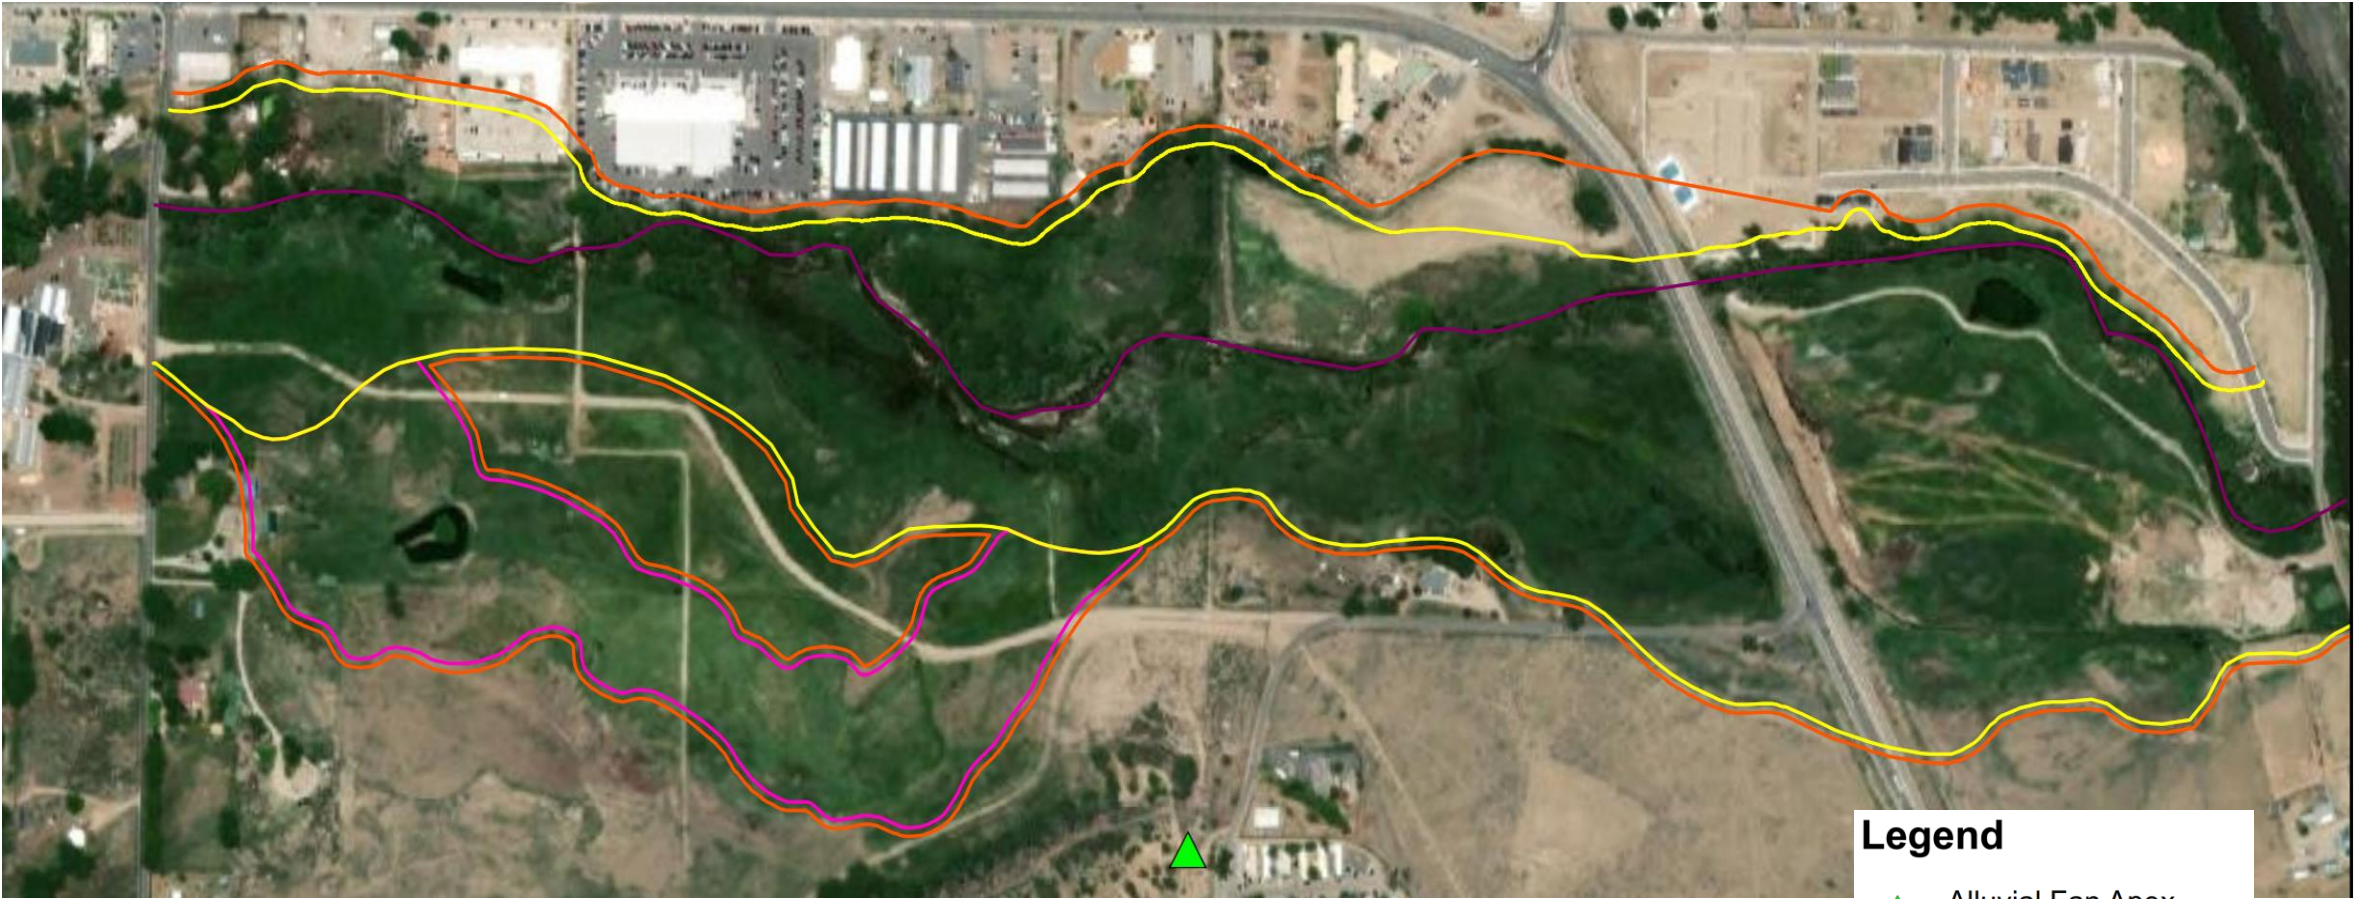
← **Conceptual Fluvial Hazards Map of the South Arkansas Corridor.** The Fluvial Hazard Zone consists of two primary components: the ASC (described above) and the Fluvial Hazard Buffer (FHB). The FHB accounts for erosion prone land located beyond the Active Stream Corridor, such as hillslopes and terraces, that may be susceptible to slope failure as a result of toe erosion caused by fluvial scour. It is a buffer applied to the outer boundary of the ASC. Avulsion Hazard Zones (AHZs) mark the area a stream may occupy and impact due to a wholesale shift in channel position on the valley floor as defined in the Colorado FHZ Protocol.

**These draft maps were developed for planning purposes only and were delineated with topographic data from a 2011 LiDAR survey.**

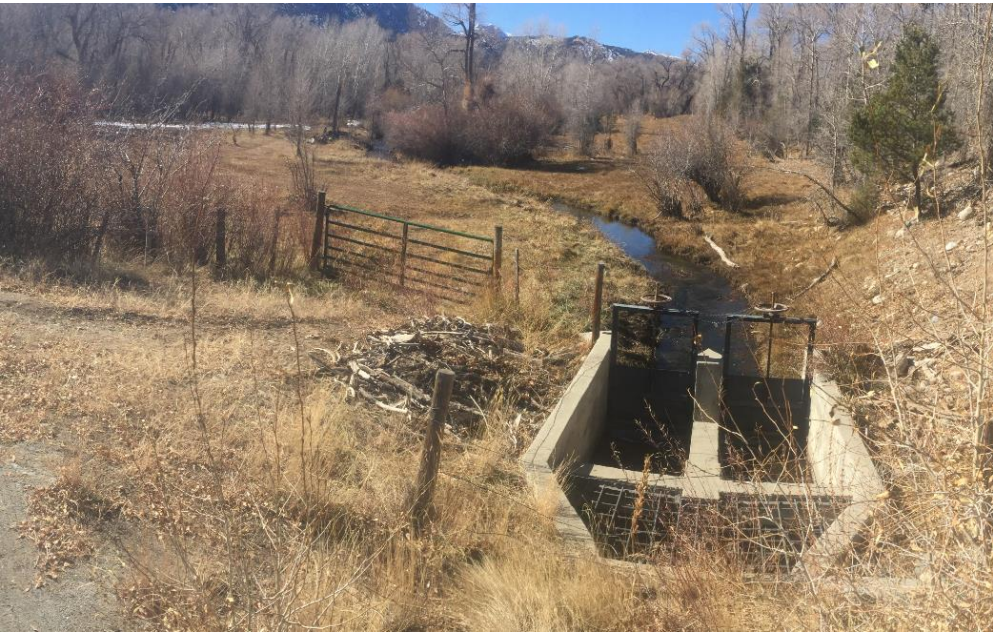
Water withdrawals and diversions →

Since flow regime on the South Arkansas is impaired by water depletion, one strategy for restoring riverscape health (theoretically) could be to curtail water diversions, but water use can be a very difficult stressor to mitigate. In most cases (as in this diversion for the Harrington Ditch, a source of municipal water for Salida) benefits to riverscape health are outweighed by other uses (*i.e.*, the need for city water. Mitigating the impacts of water diversions would involve a complex collaborative effort on a watershed scale.

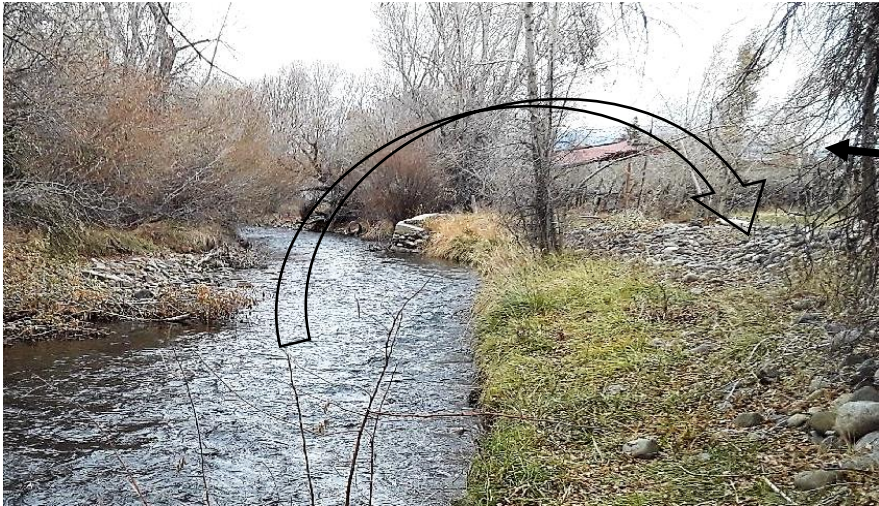
Channelization upstream of the Highway 50 culverts.

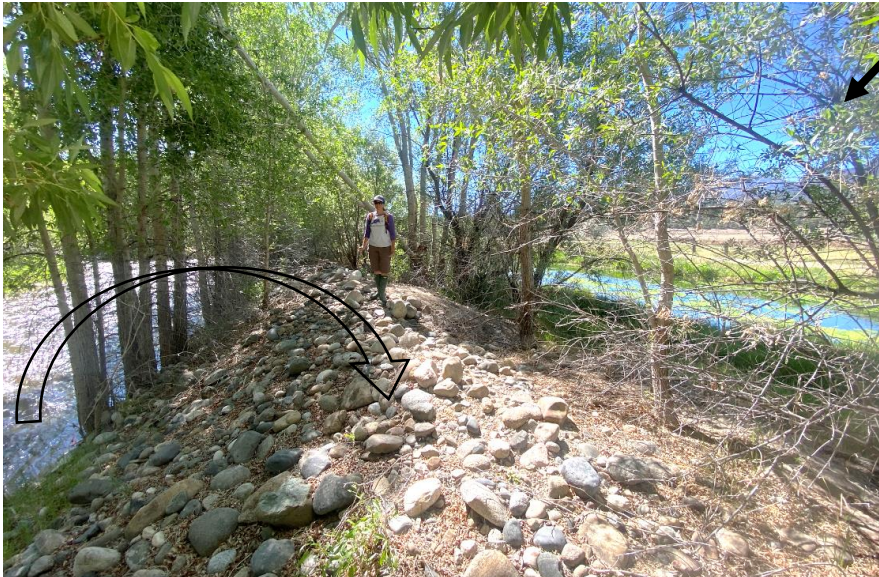
↑ Levees like these (above and below) were constructed during channelization projects in the 1940s or 50s by excavating the channel bed to build berms to create an incised channel with elevated banks—a double-whammy in terms of entrenchment. ↓

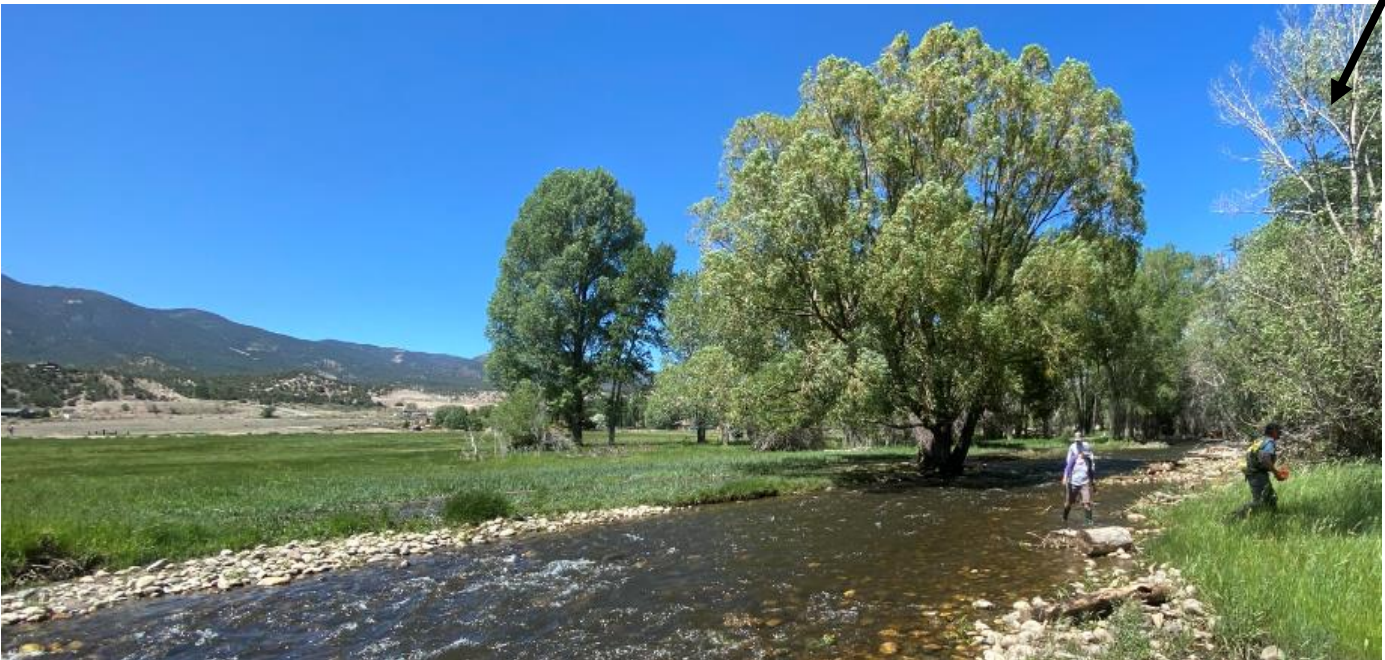
↑ 73% of the riverscape on the TR segment is being developed. Active riparian habitat occupies 9%.

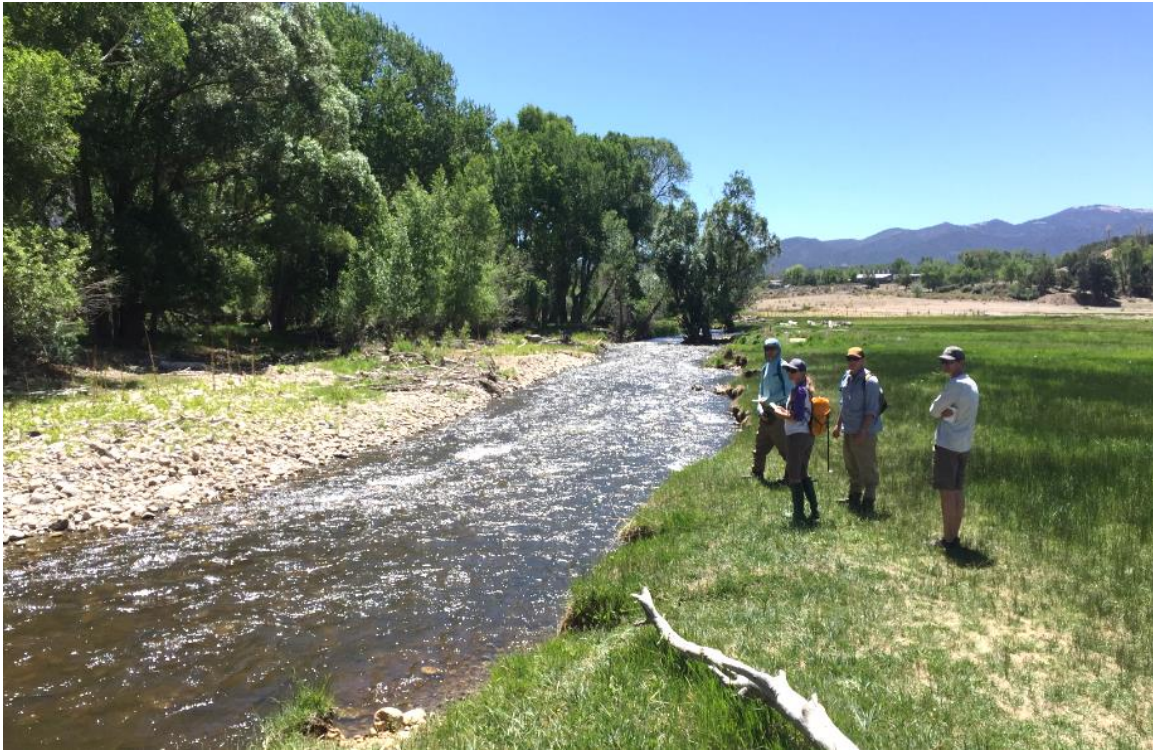
↑ Despite above average snowfall, 2020 runoff peaked at about 140 CFS. Shown here on the receding limb at about 60 CFS on the VS segment on June 8.

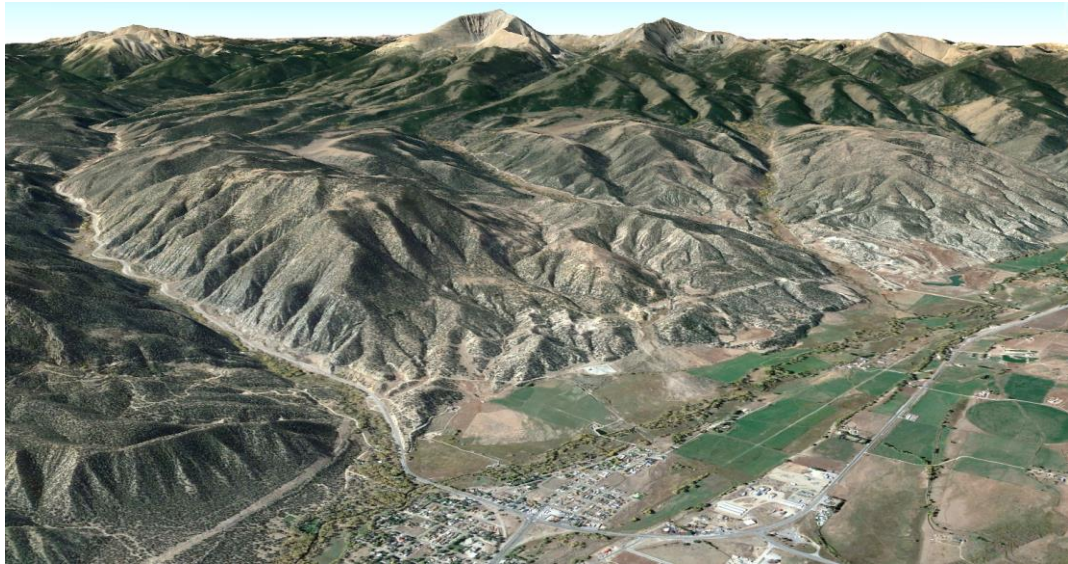
↑ The 2014 SAWC report expressed concern about potential for increased sedimentation due to land use disturbance on erodible soil in the watershed (left), and channel erosion due to local vegetation impacts, and conversion of wetland to upland or bare ground (right).

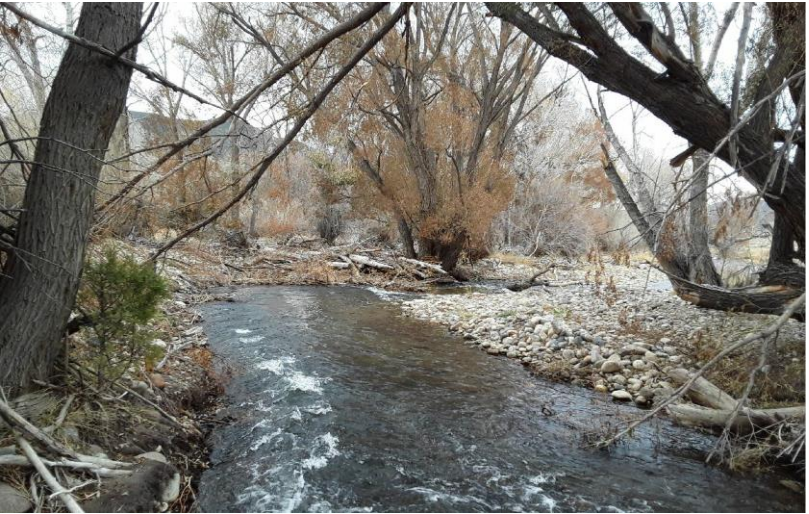
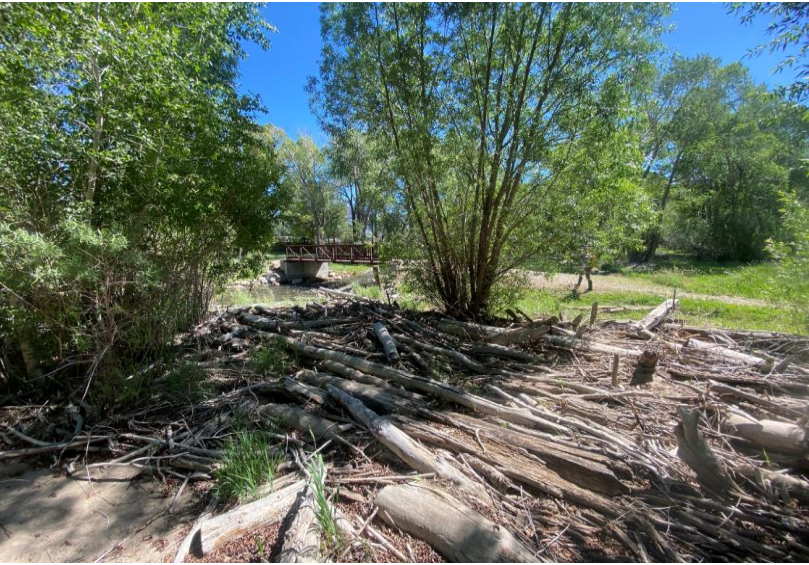
→ Wood jams (above) and wrack (below) are indicators of recent large woody material supply.

Systematic wood removal from the stream (as evidenced by wood spoils like those in the upper photo) is part of maintenance plans on the South Arkansas to reduce the risk of clogging crossings (like the one at Highway 50 in the lower photo) that were not designed to pass natural loads of large woody material.

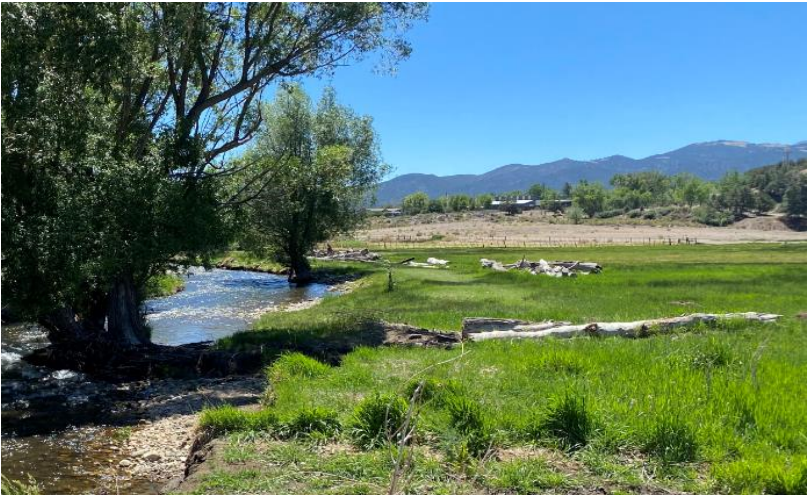
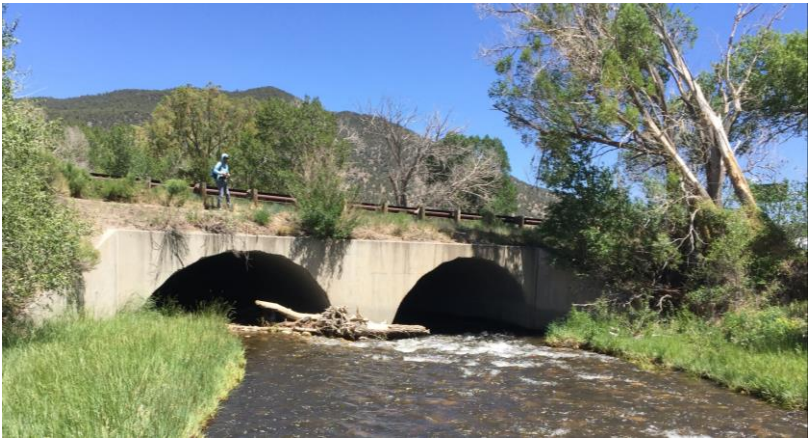
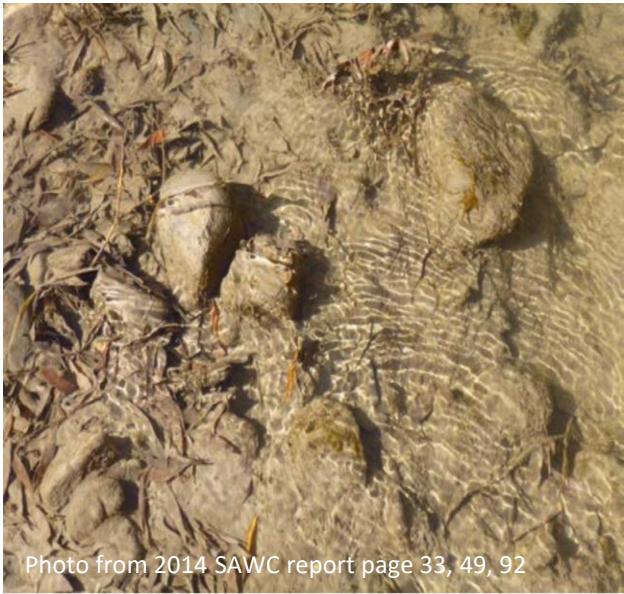
Photo from 2014 SAWC report page 33, 49, 92

← The 2014 SAWC report expressed concern about excessive sediment deposition on the reach downstream of CR 107 based on observed silt and detritus accumulation after thunderstorms in 2012. Silt and fine organic material like this does accumulate temporarily, but it rapidly flushes when flows reach moderate discharge. Areas of fine sediment substrate and detritus accumulations such as leaf packs are in fact extraordinarily rare on this reach of the South Arkansas.

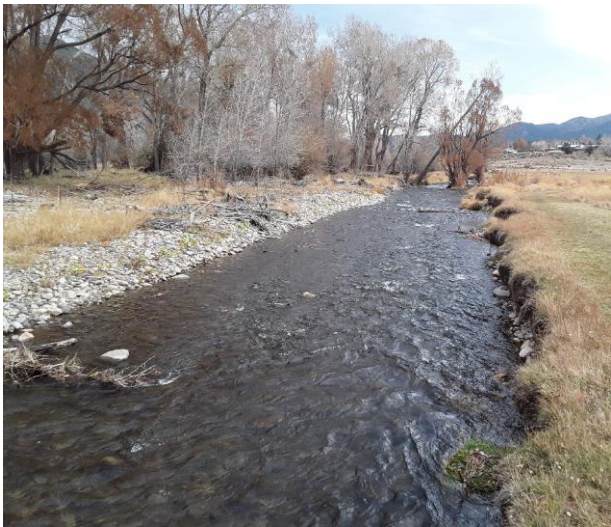
Any increases to fine sediment supply may be offset by artificially high scour energy on the reach. In its channelized form with high velocity flows and high stream power, shear stress keeps sediment moving. Fine material and detritus are flushed through and rifle embeddedness is extremely low. High rates of bedload transport are observed in years with significant peak flows. →

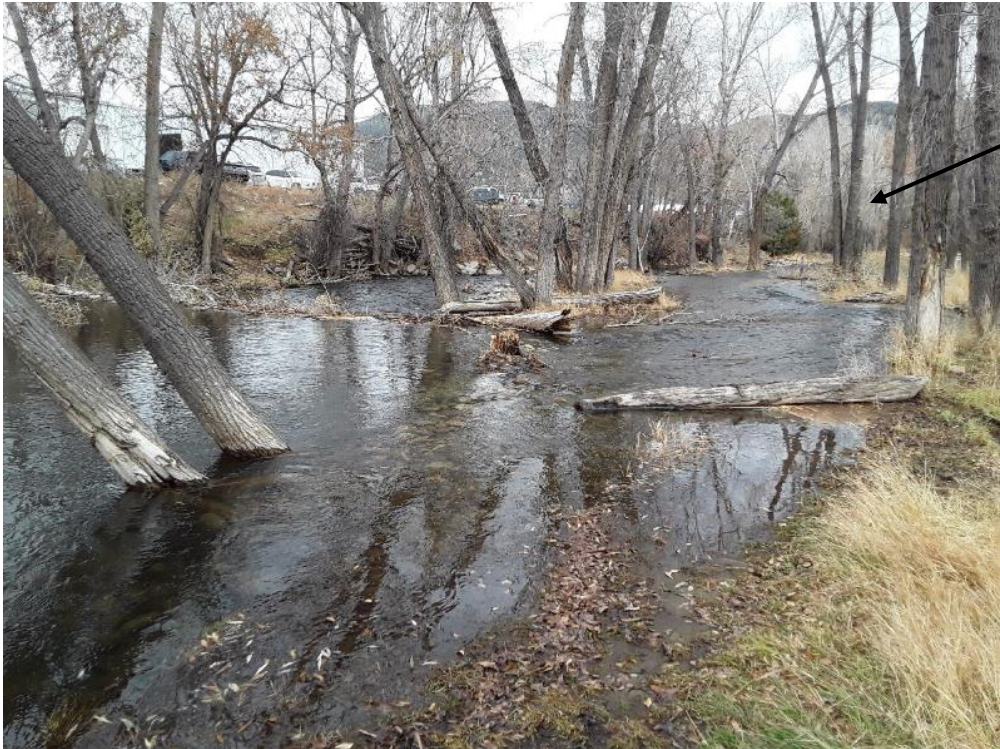
↑ On the segments that are not entrenched, and where natural processes like aggradation and wood accumulation are tolerated, frequently saturated area is much wider than on more highly impaired segments.

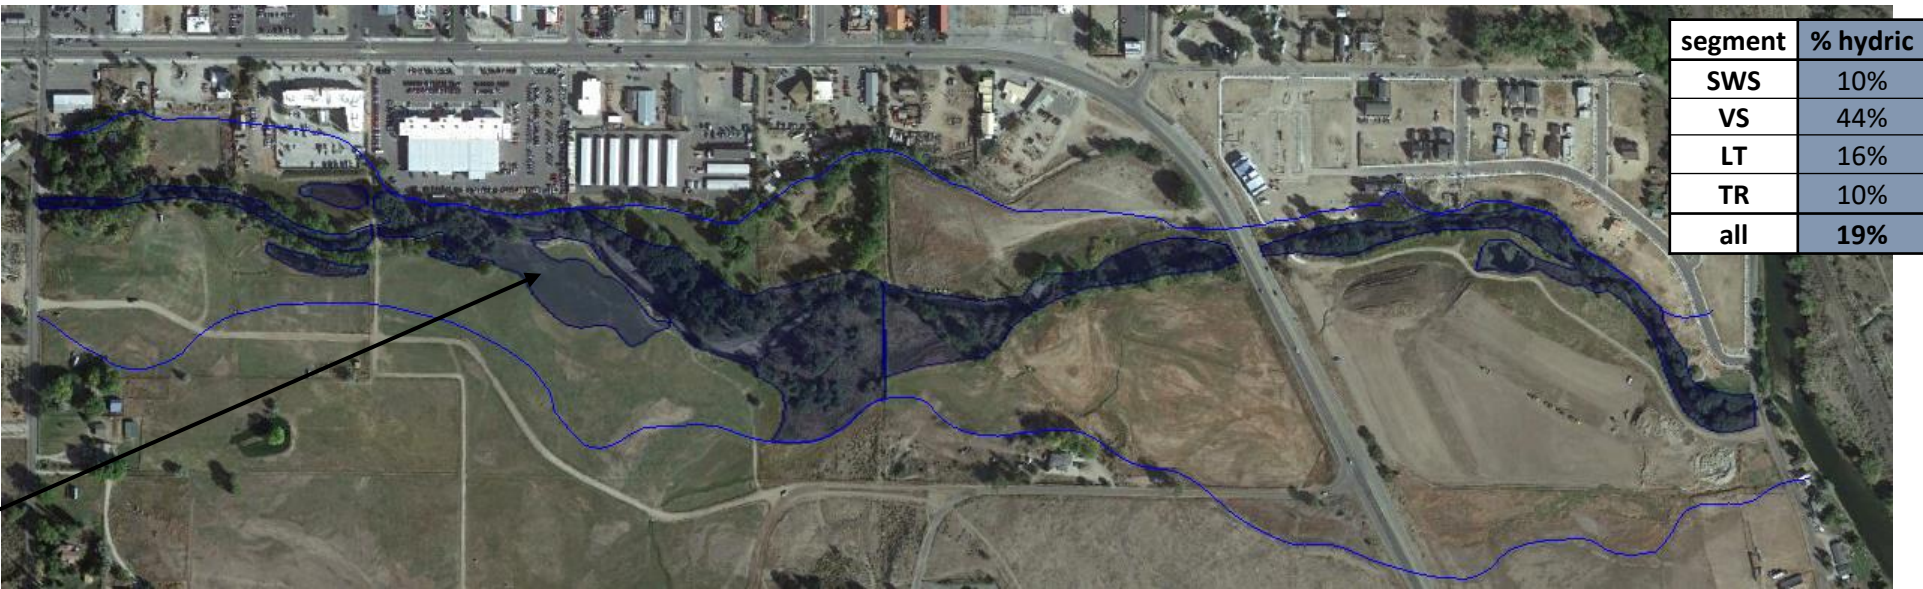
### Frequently saturated area →

Frequently saturated area may be identified by the distribution of aquatic habitat and hydric vegetation (shaded blue), which is currently limited to 19% of the stream corridor (outline) over the reach. Values range from 10% on the SWS and TR segments, 16% on the LT segment, to 44% on the VS segment.

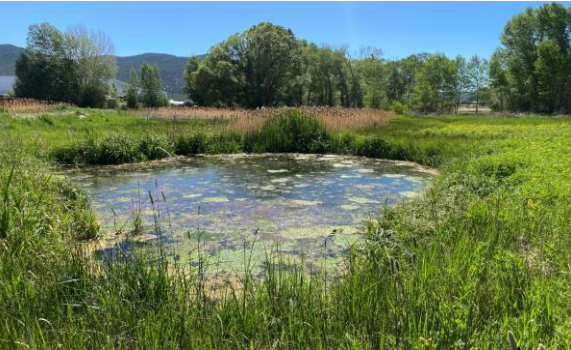
↑ Constructed herbaceous wetland

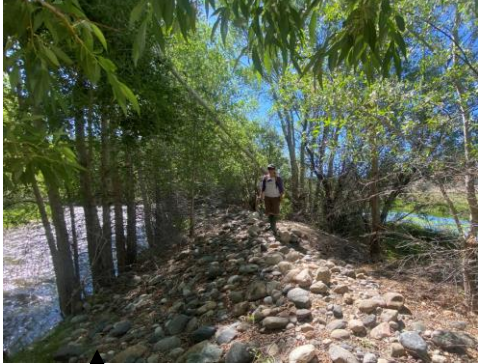
↓ Dry woodland on levees

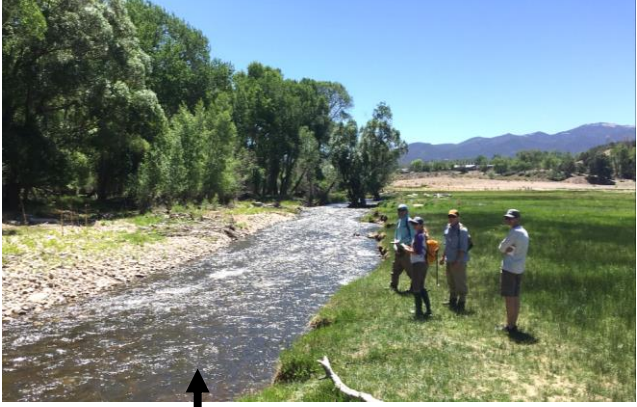
↓ Wet woodland (left), wet herbaceous (right)

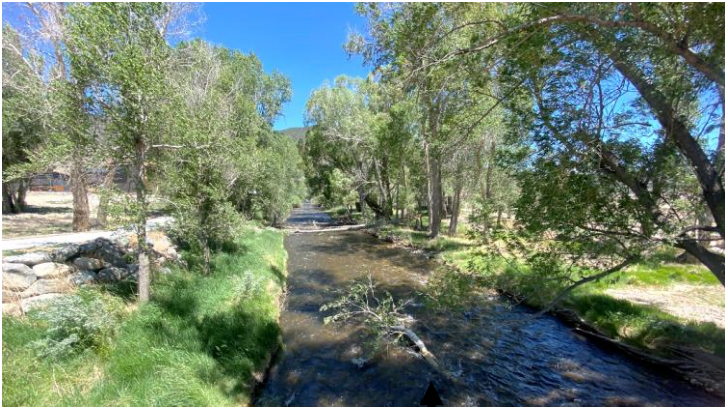
↓ Developed area with narrow band of wet woodland

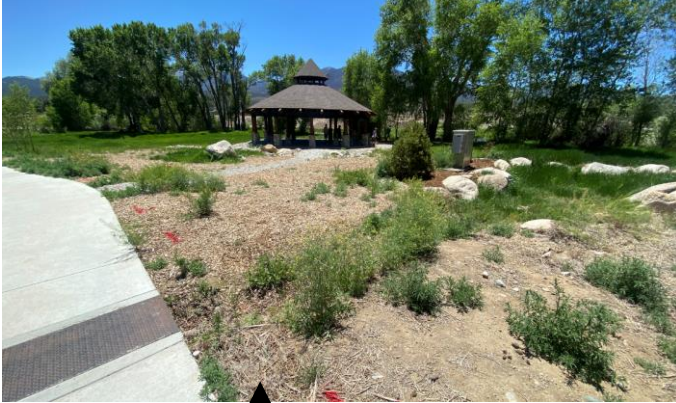
↓ Developed area with recent landscaping

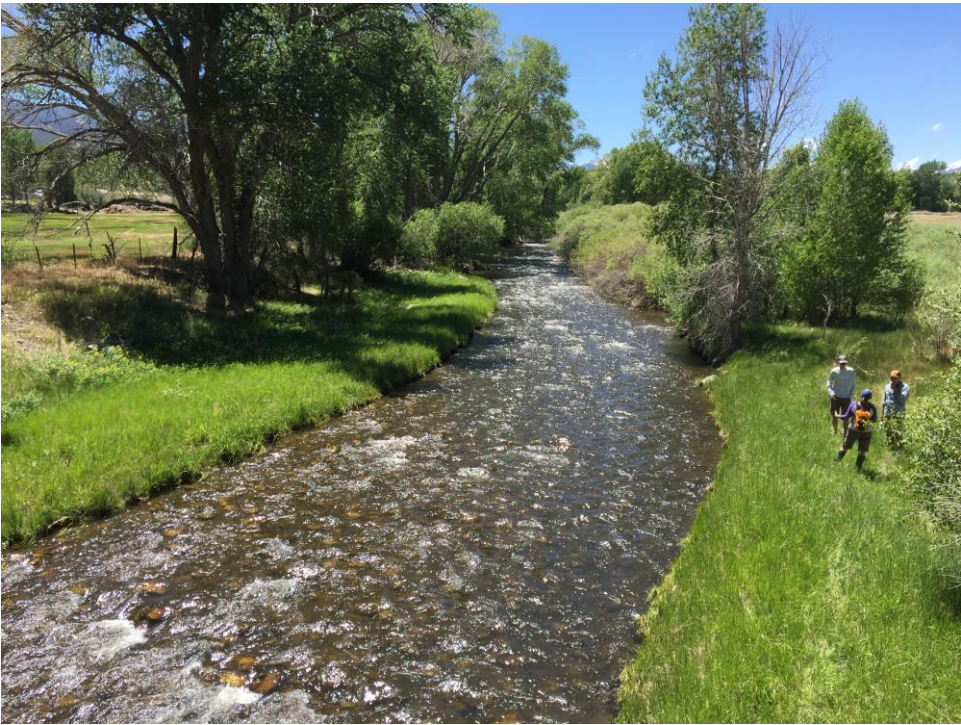
↑ Aquatic and riparian habitat heterogeneity is severely lacking on most of the reach due to channelization.

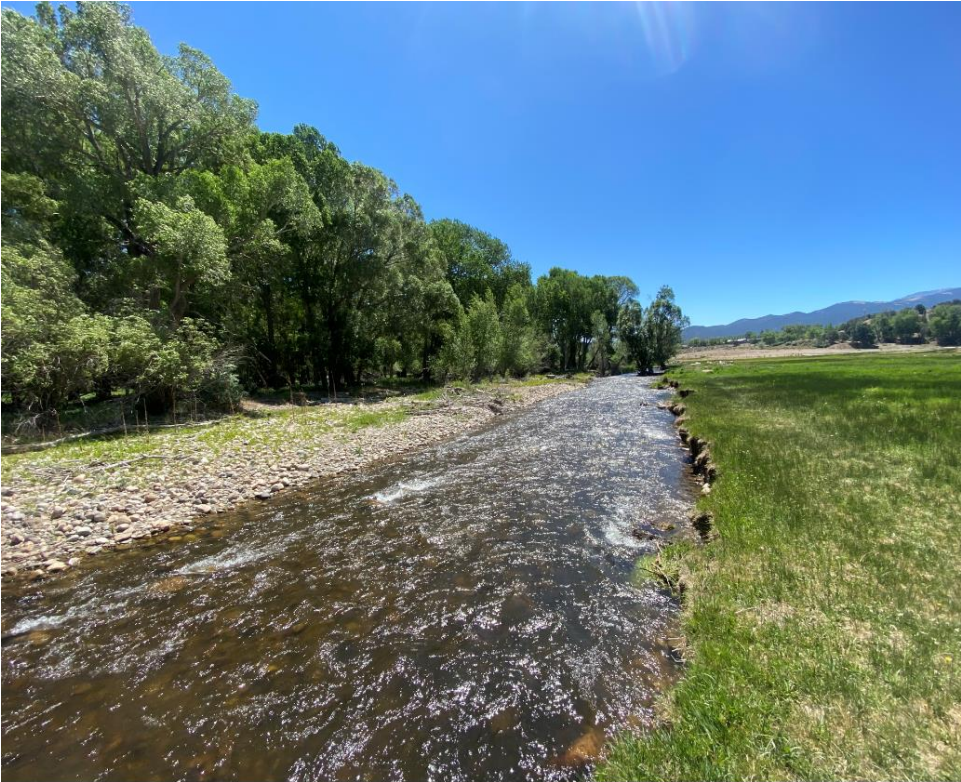
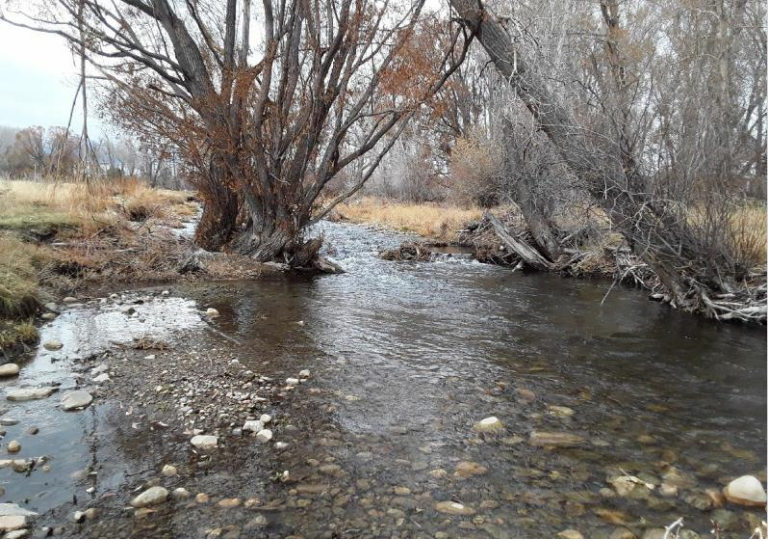
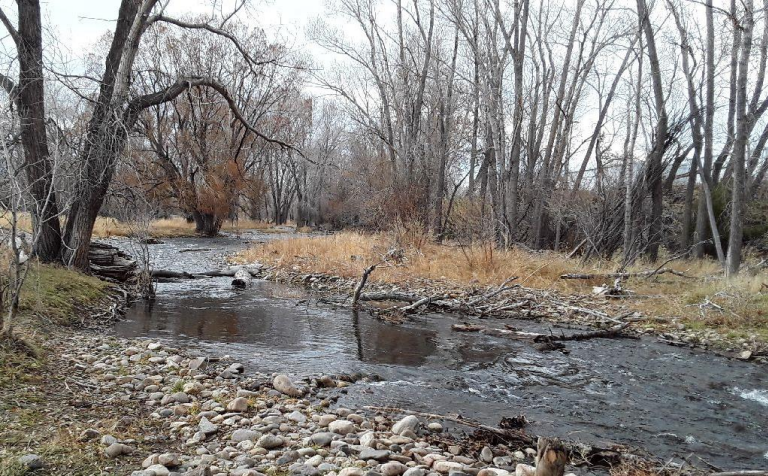
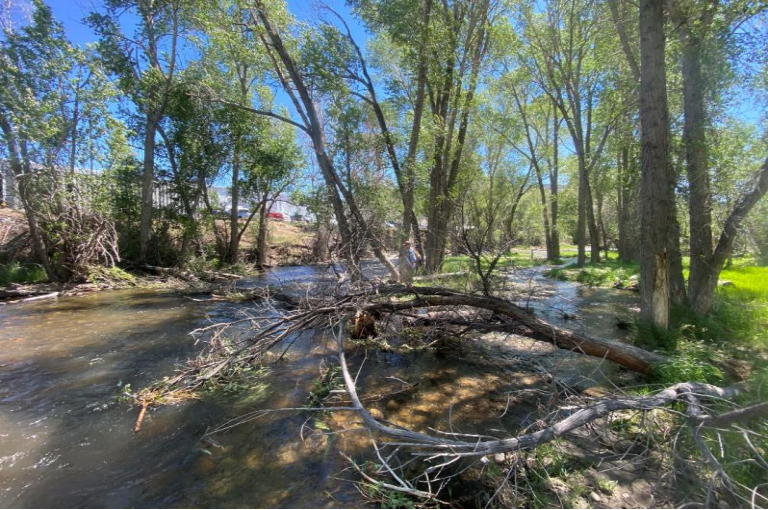
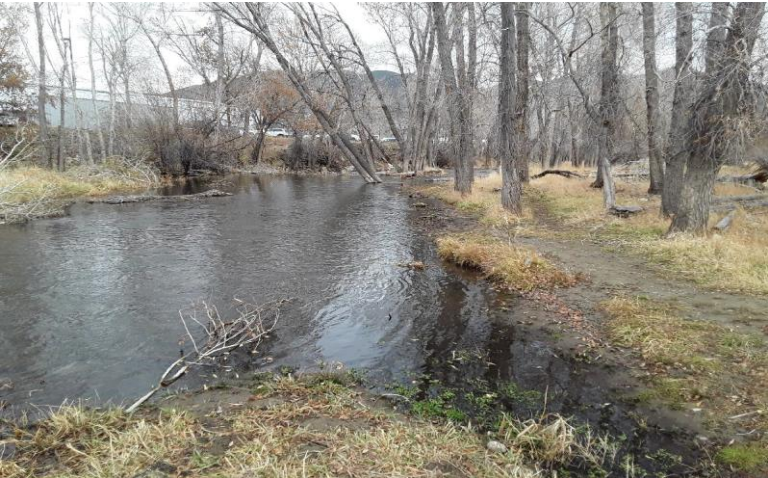
Aquatic habitat is homogenous gravel-cobble-bed riffle with few pools or other structural features except where wood initiates scour and deposition. Much of the riparian zone is homogenous pasture. ↓

Habitat complexity in the VS segment is improving where wood and coarse sediment has been accumulating to create scour pools, backwater pools, slack water, wood cover, detritus packs, side channels, emergent wetland, and both coarse and fine structural heterogeneity to add diversity to the otherwise homogenous plane-bed riffle bedform that exists over most of the rest of the reach.

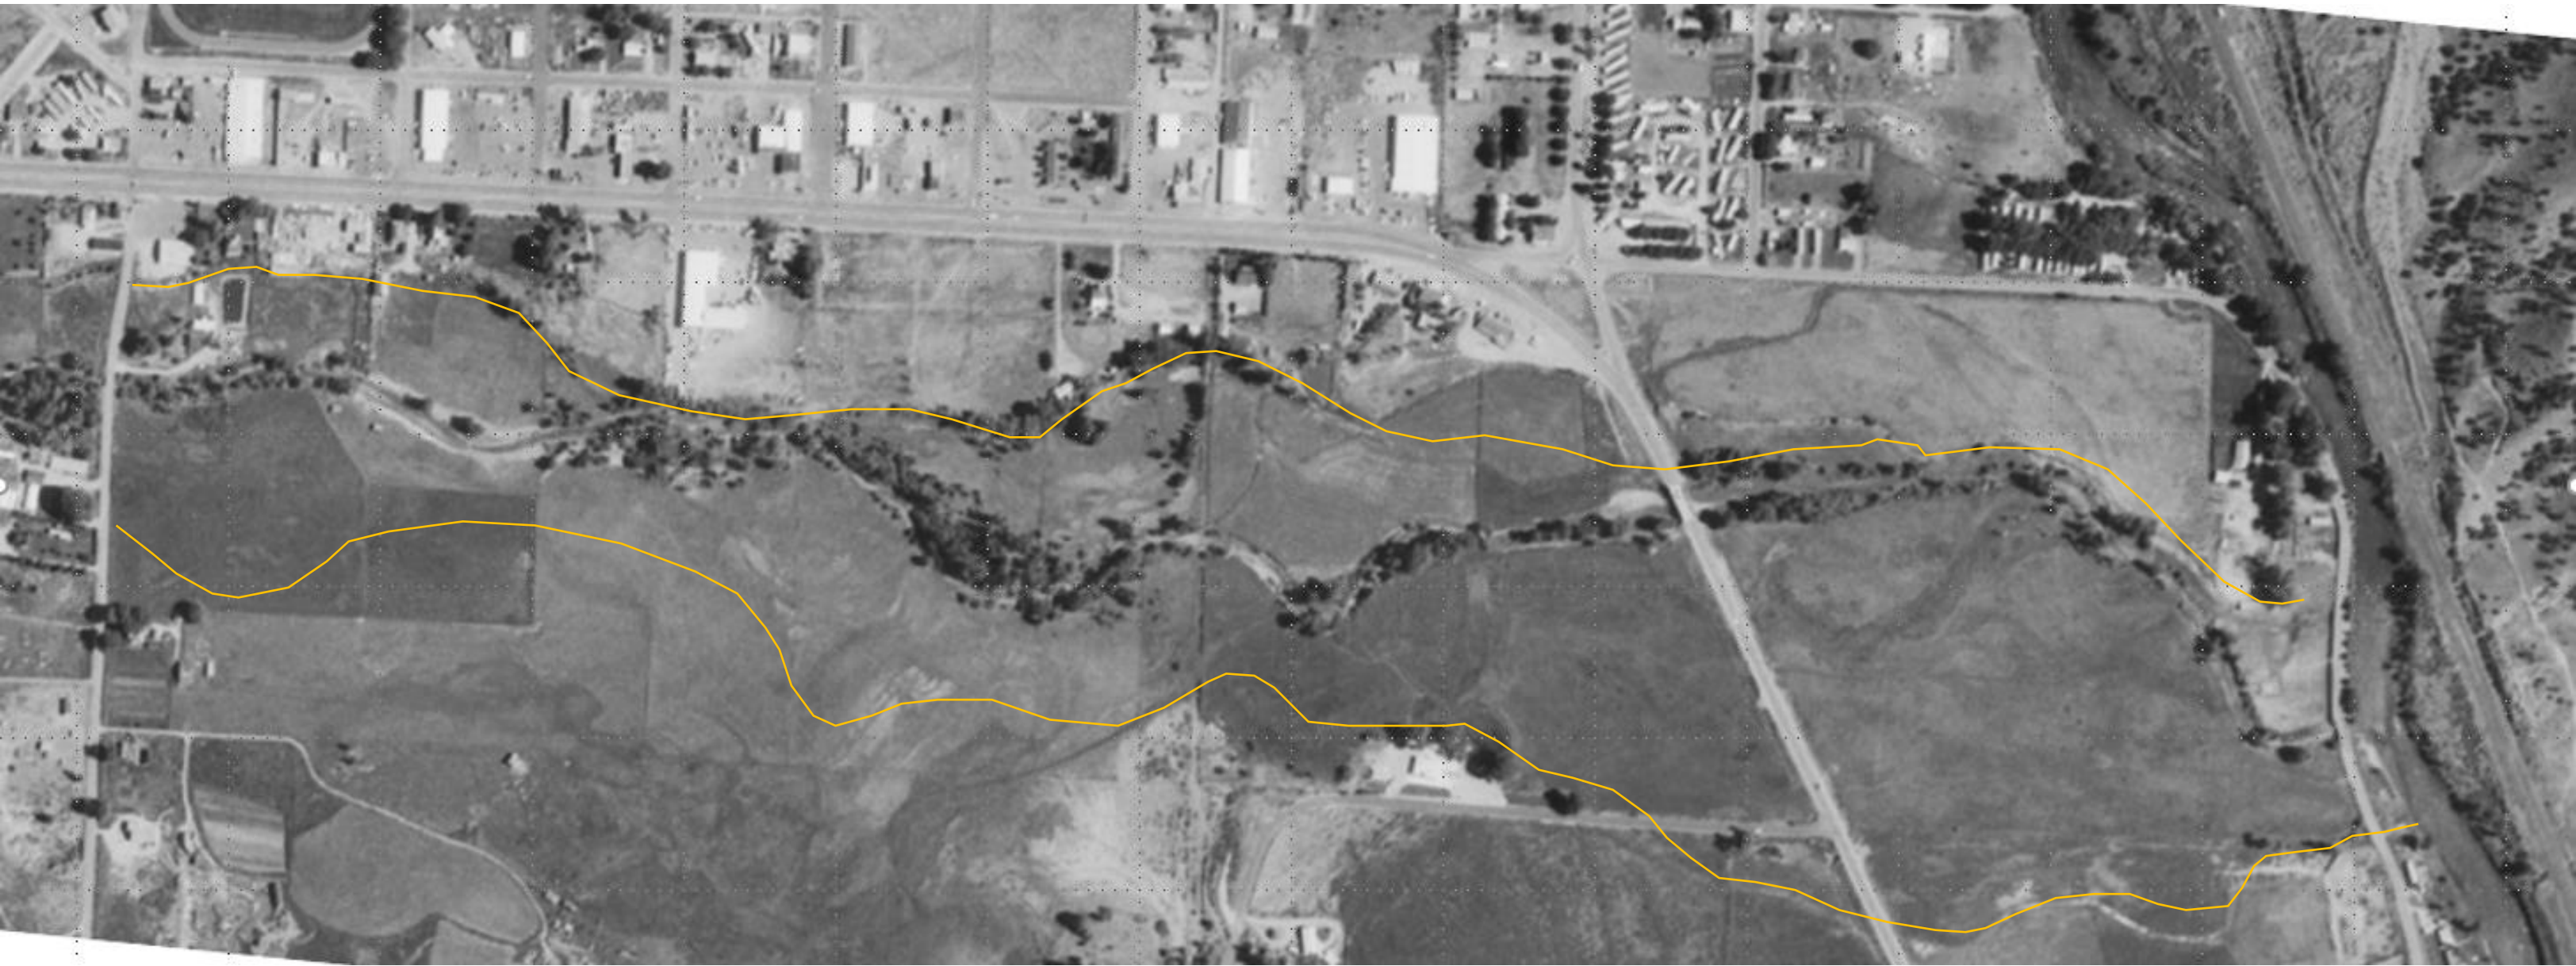
# 1976

Between 1961 and 1976, there were no new major land use changes in the riverscape corridor.

— Margins of stream corridor (natural riparian extent)

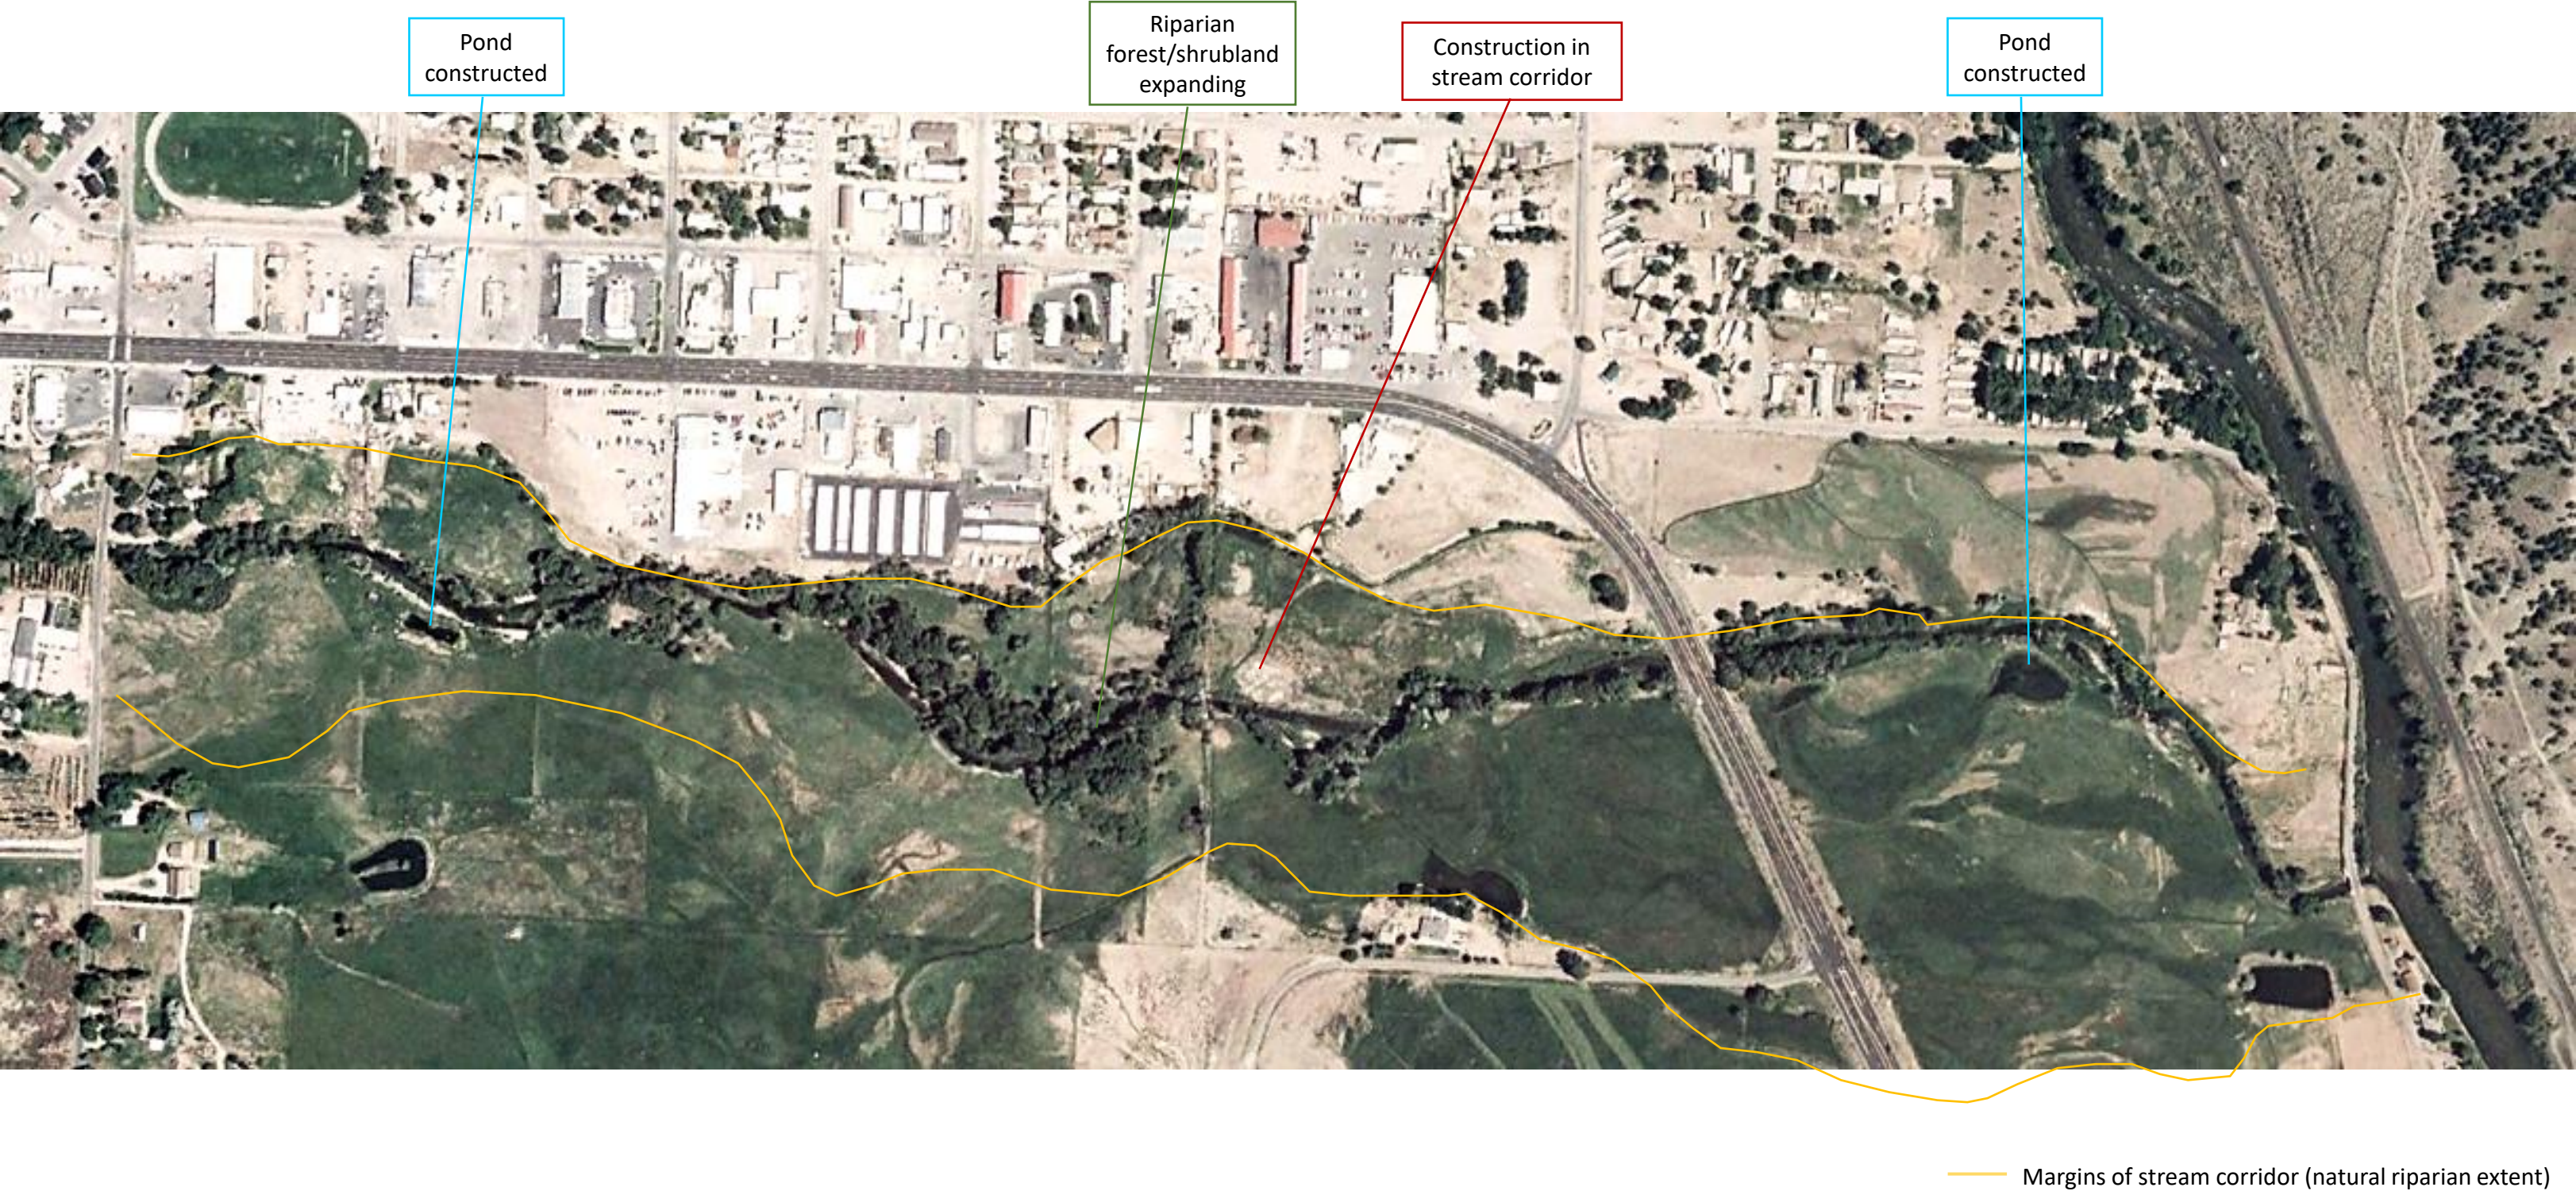
# 2005

Between 1999 and 2005, riparian forest/shrubland continued expanded further on segments in the middle of the reach. Two more new ponds were constructed in the stream corridor. New construction disturbance was evident upstream of Highway 50.
