# South Arkansas River Stream Health Assessment

## County Road 107 to confluence

December 18, 2020

Central Colorado Conservancy, Salida

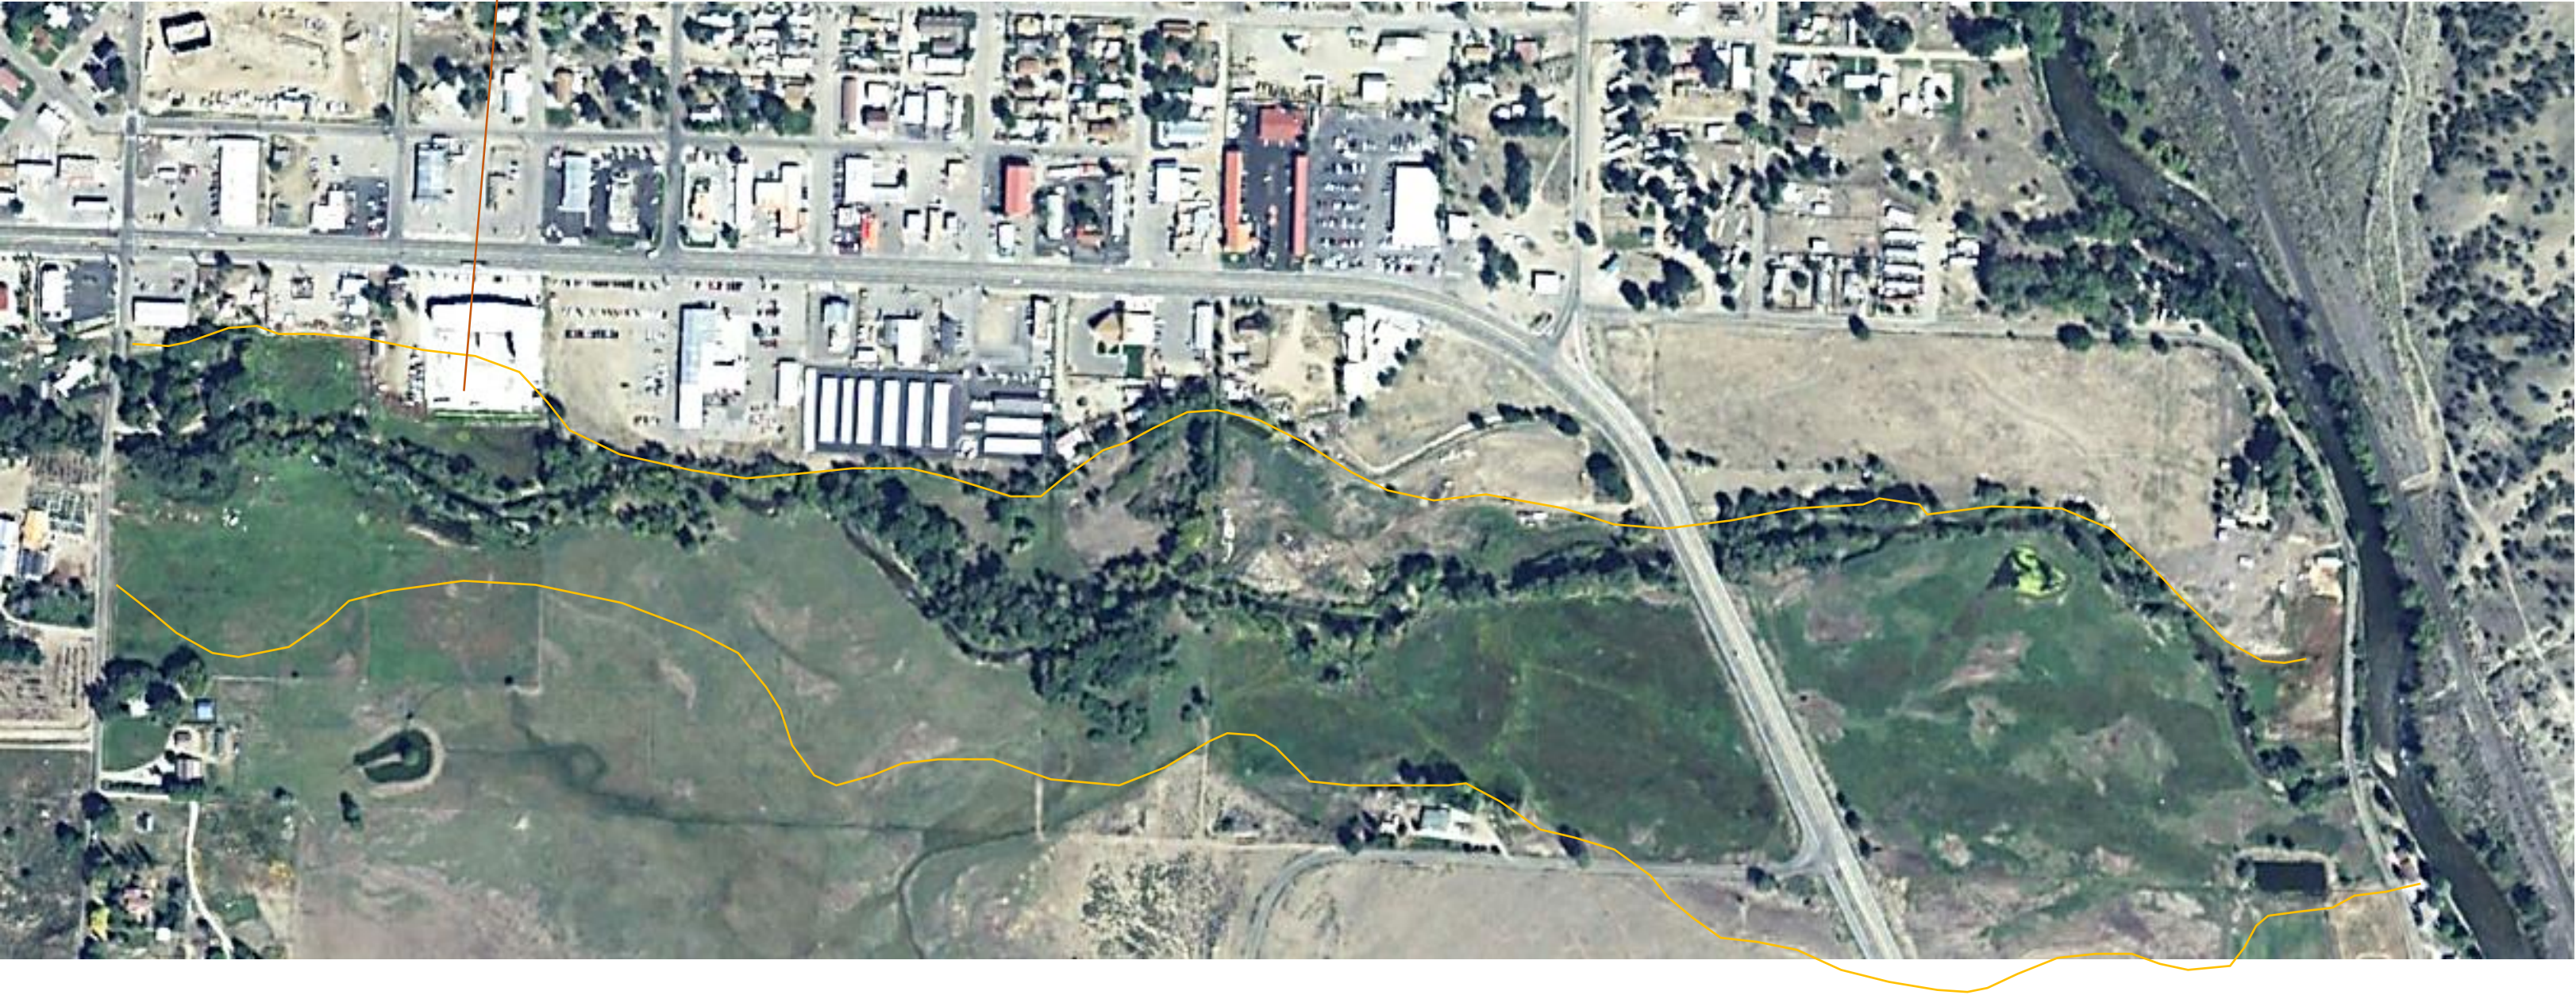
# 2011

Between 2005 and 2011, urban development encroached on the riverscape with the construction of a hotel and parking lot in the stream corridor on the upper portion of the reach.

New development  
in stream corridor

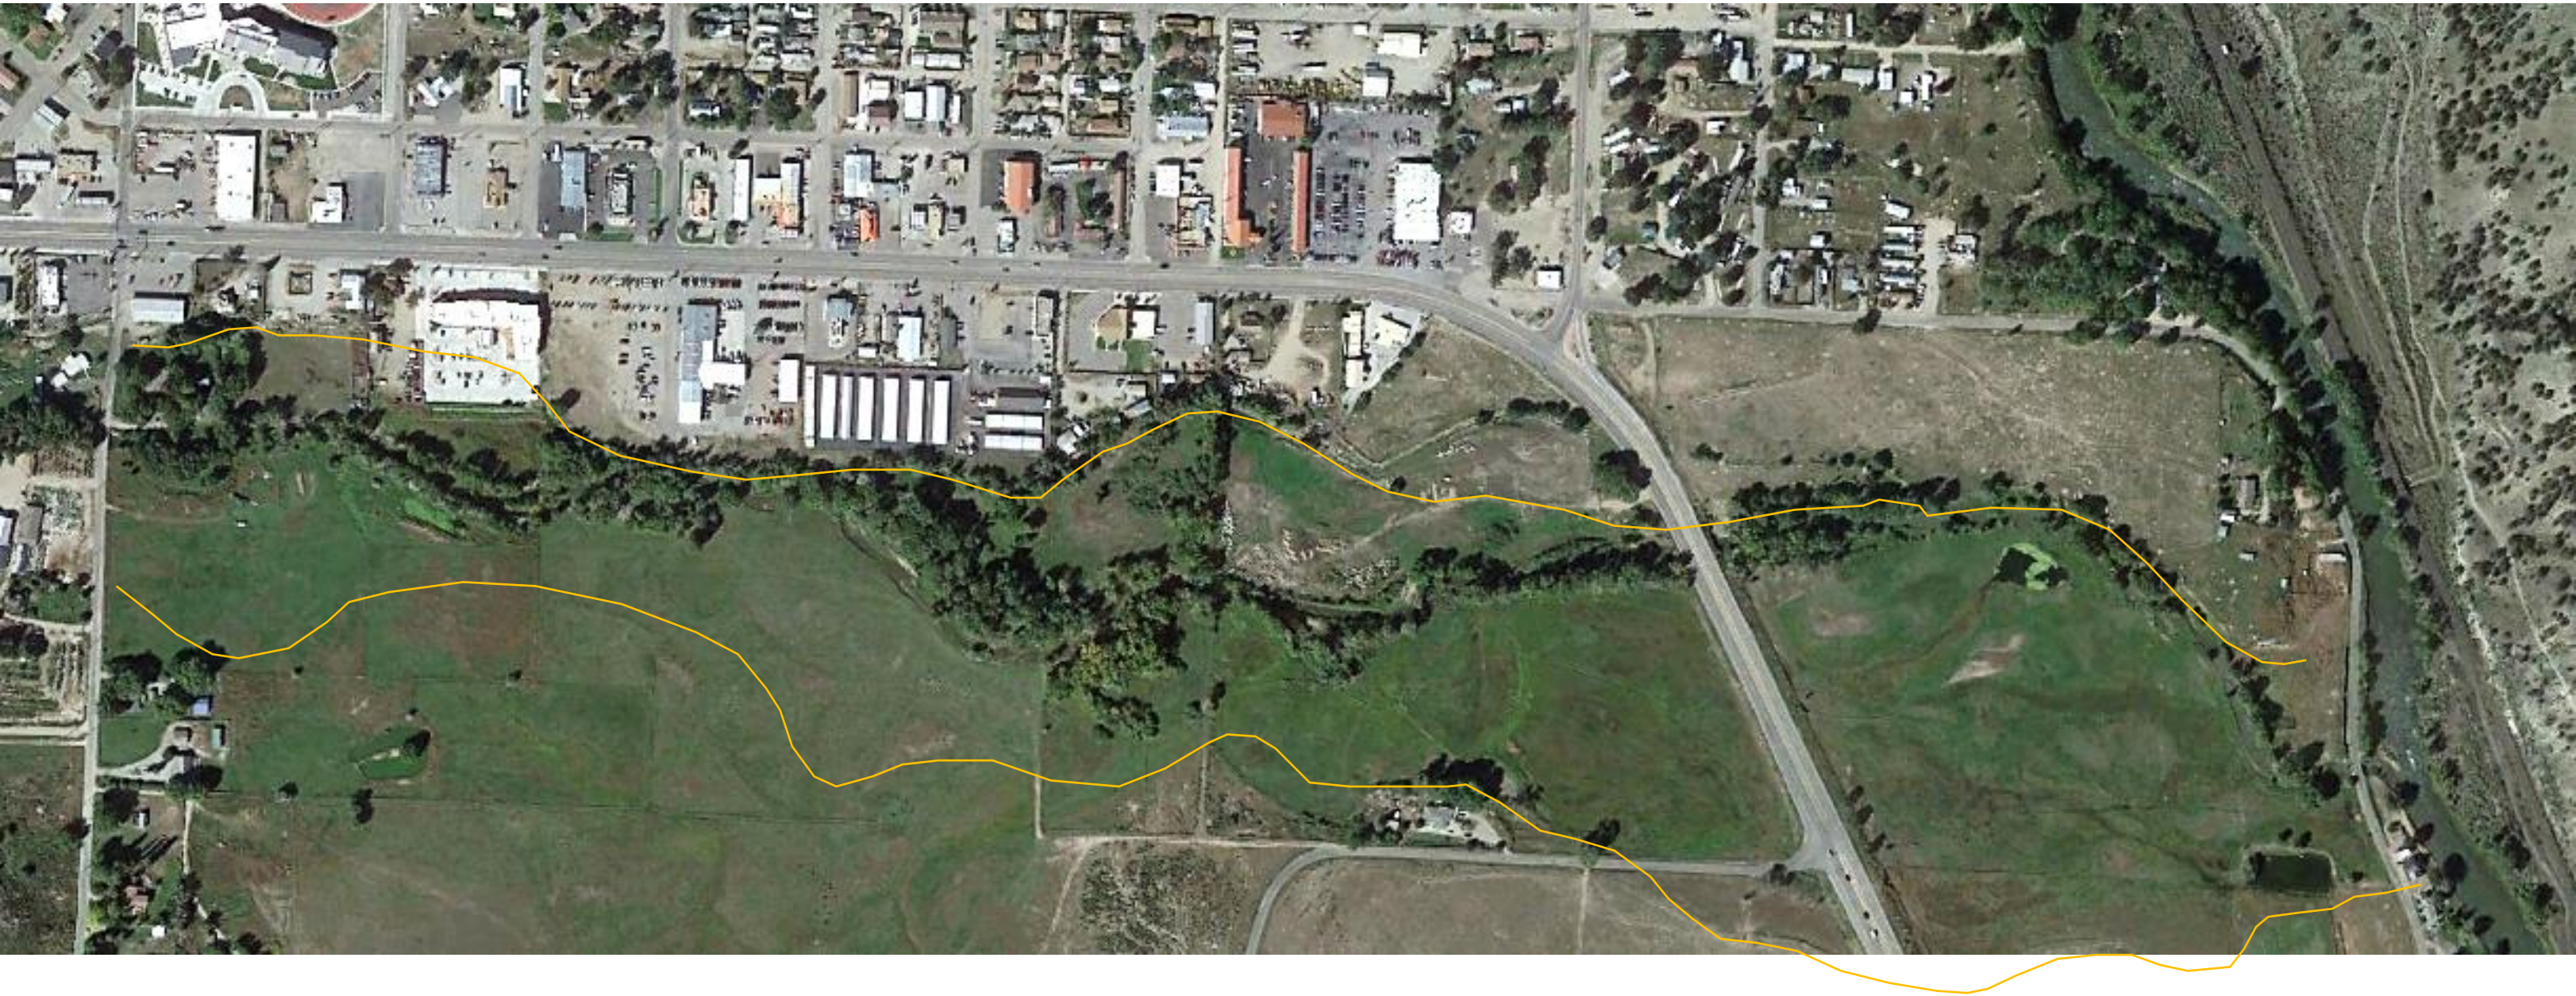
# 2013

Between 2011 and 2013, there appeared to be little significant land use change in the stream corridor.

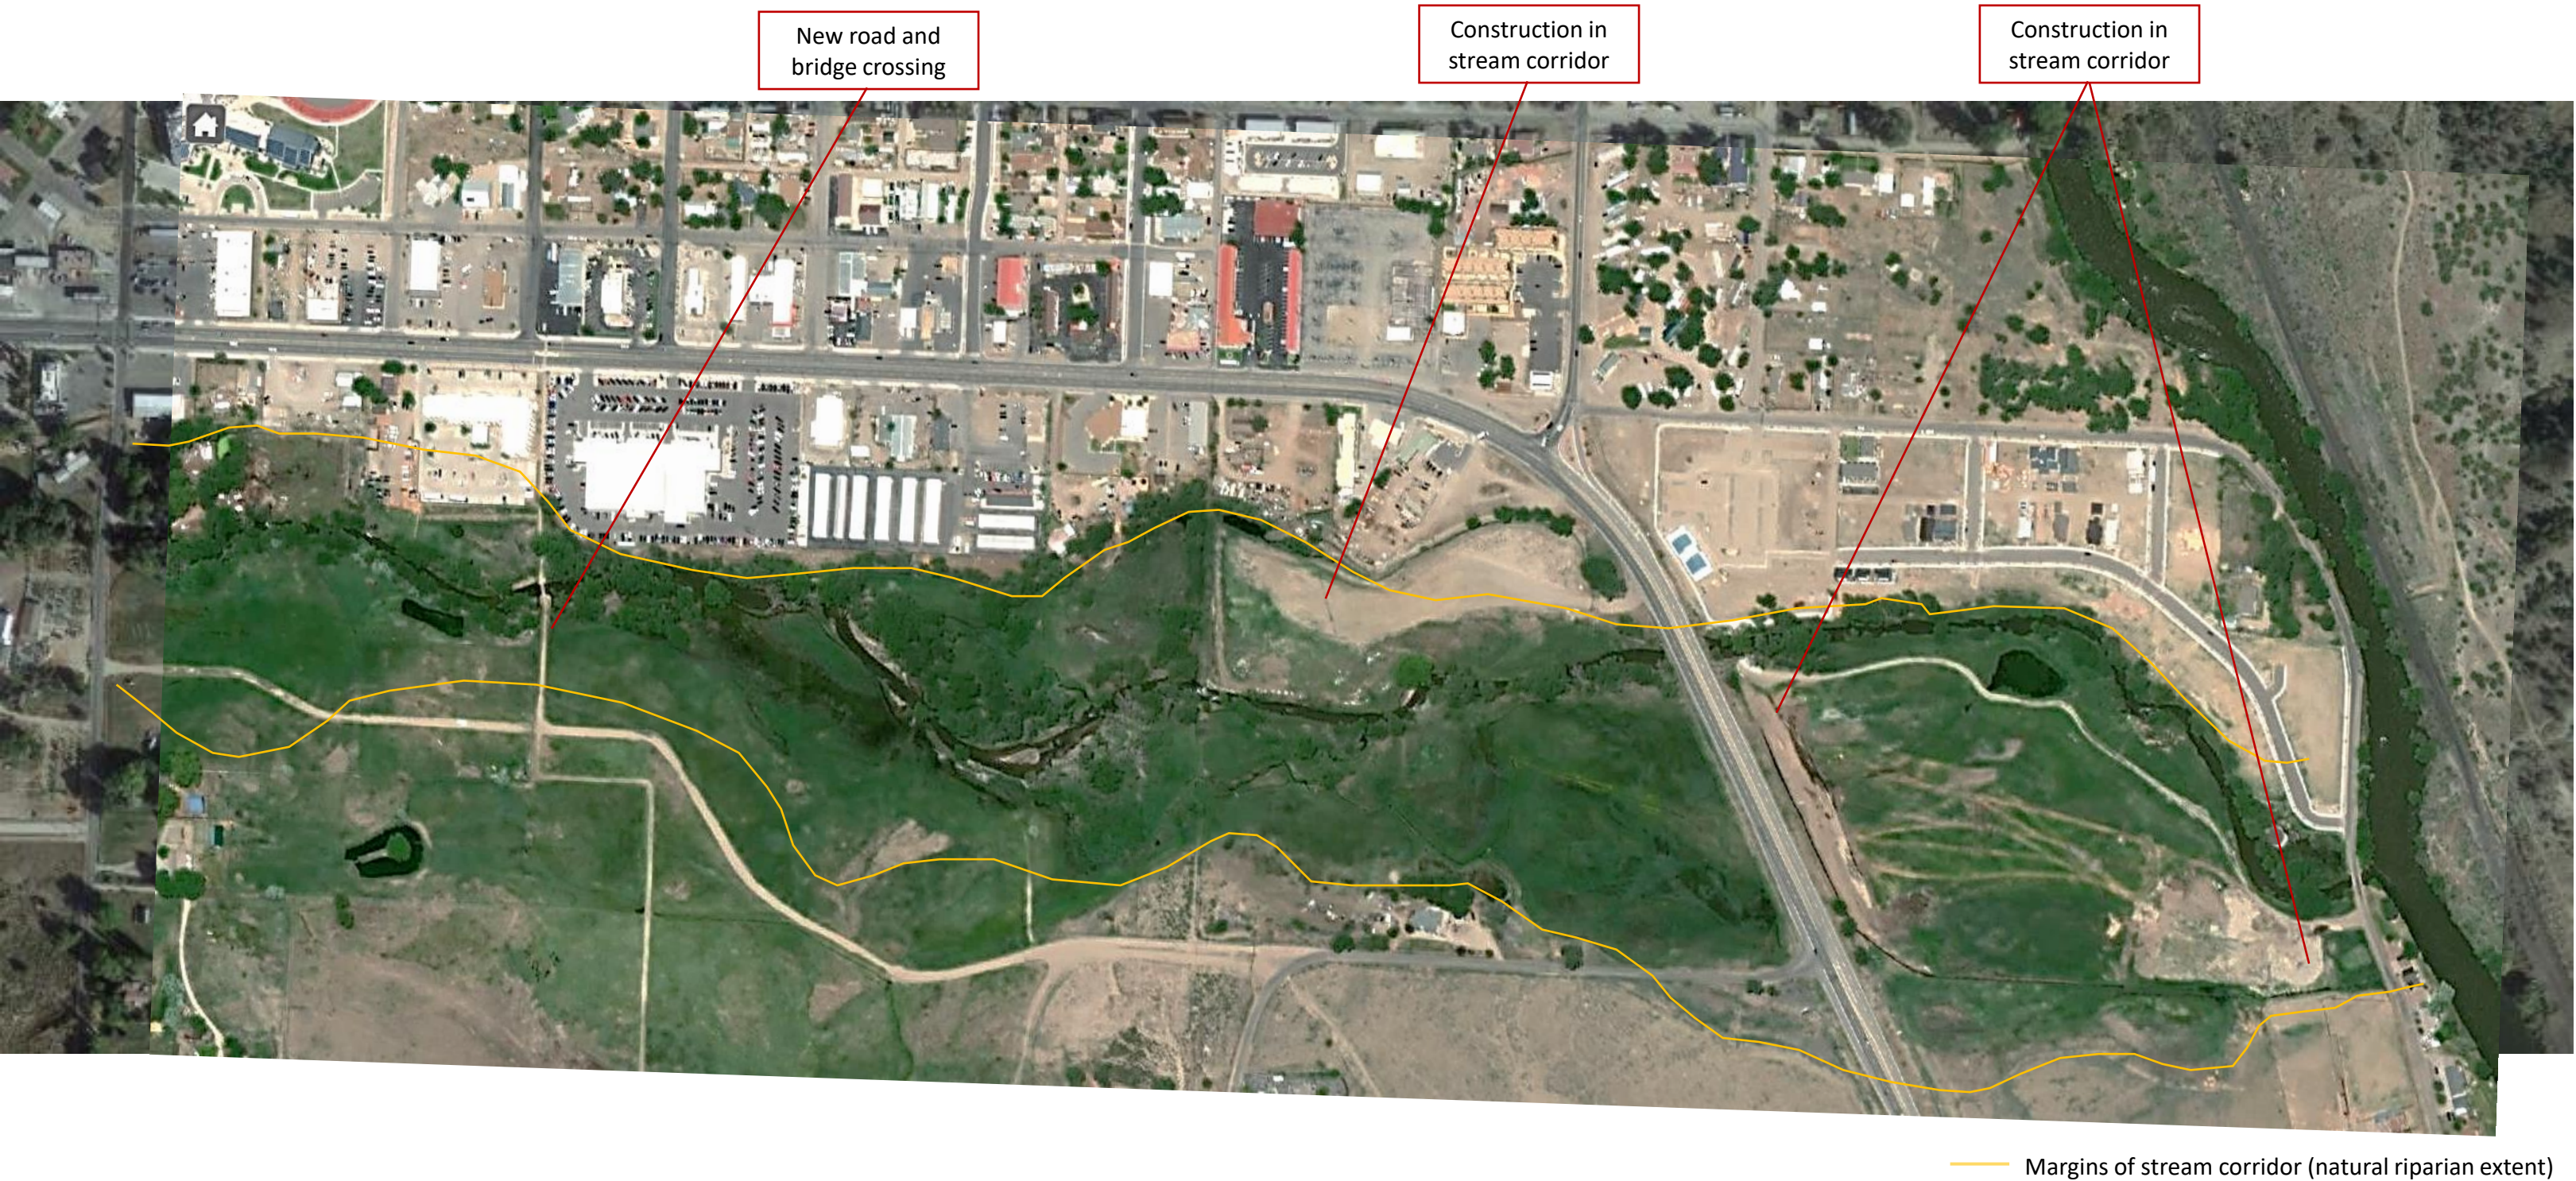
# 2018

Between 2013 and 2018, construction disturbance was evident above and below Highway 50. Floodplain fill, drainage, and new roads for the Two Rivers housing development that will occupy most of the stream corridor below Highway 50 were in progress in 2018. A new road/trail and bridge were built, creating a new corridor-spanning physical and hydrological barrier and constriction point.

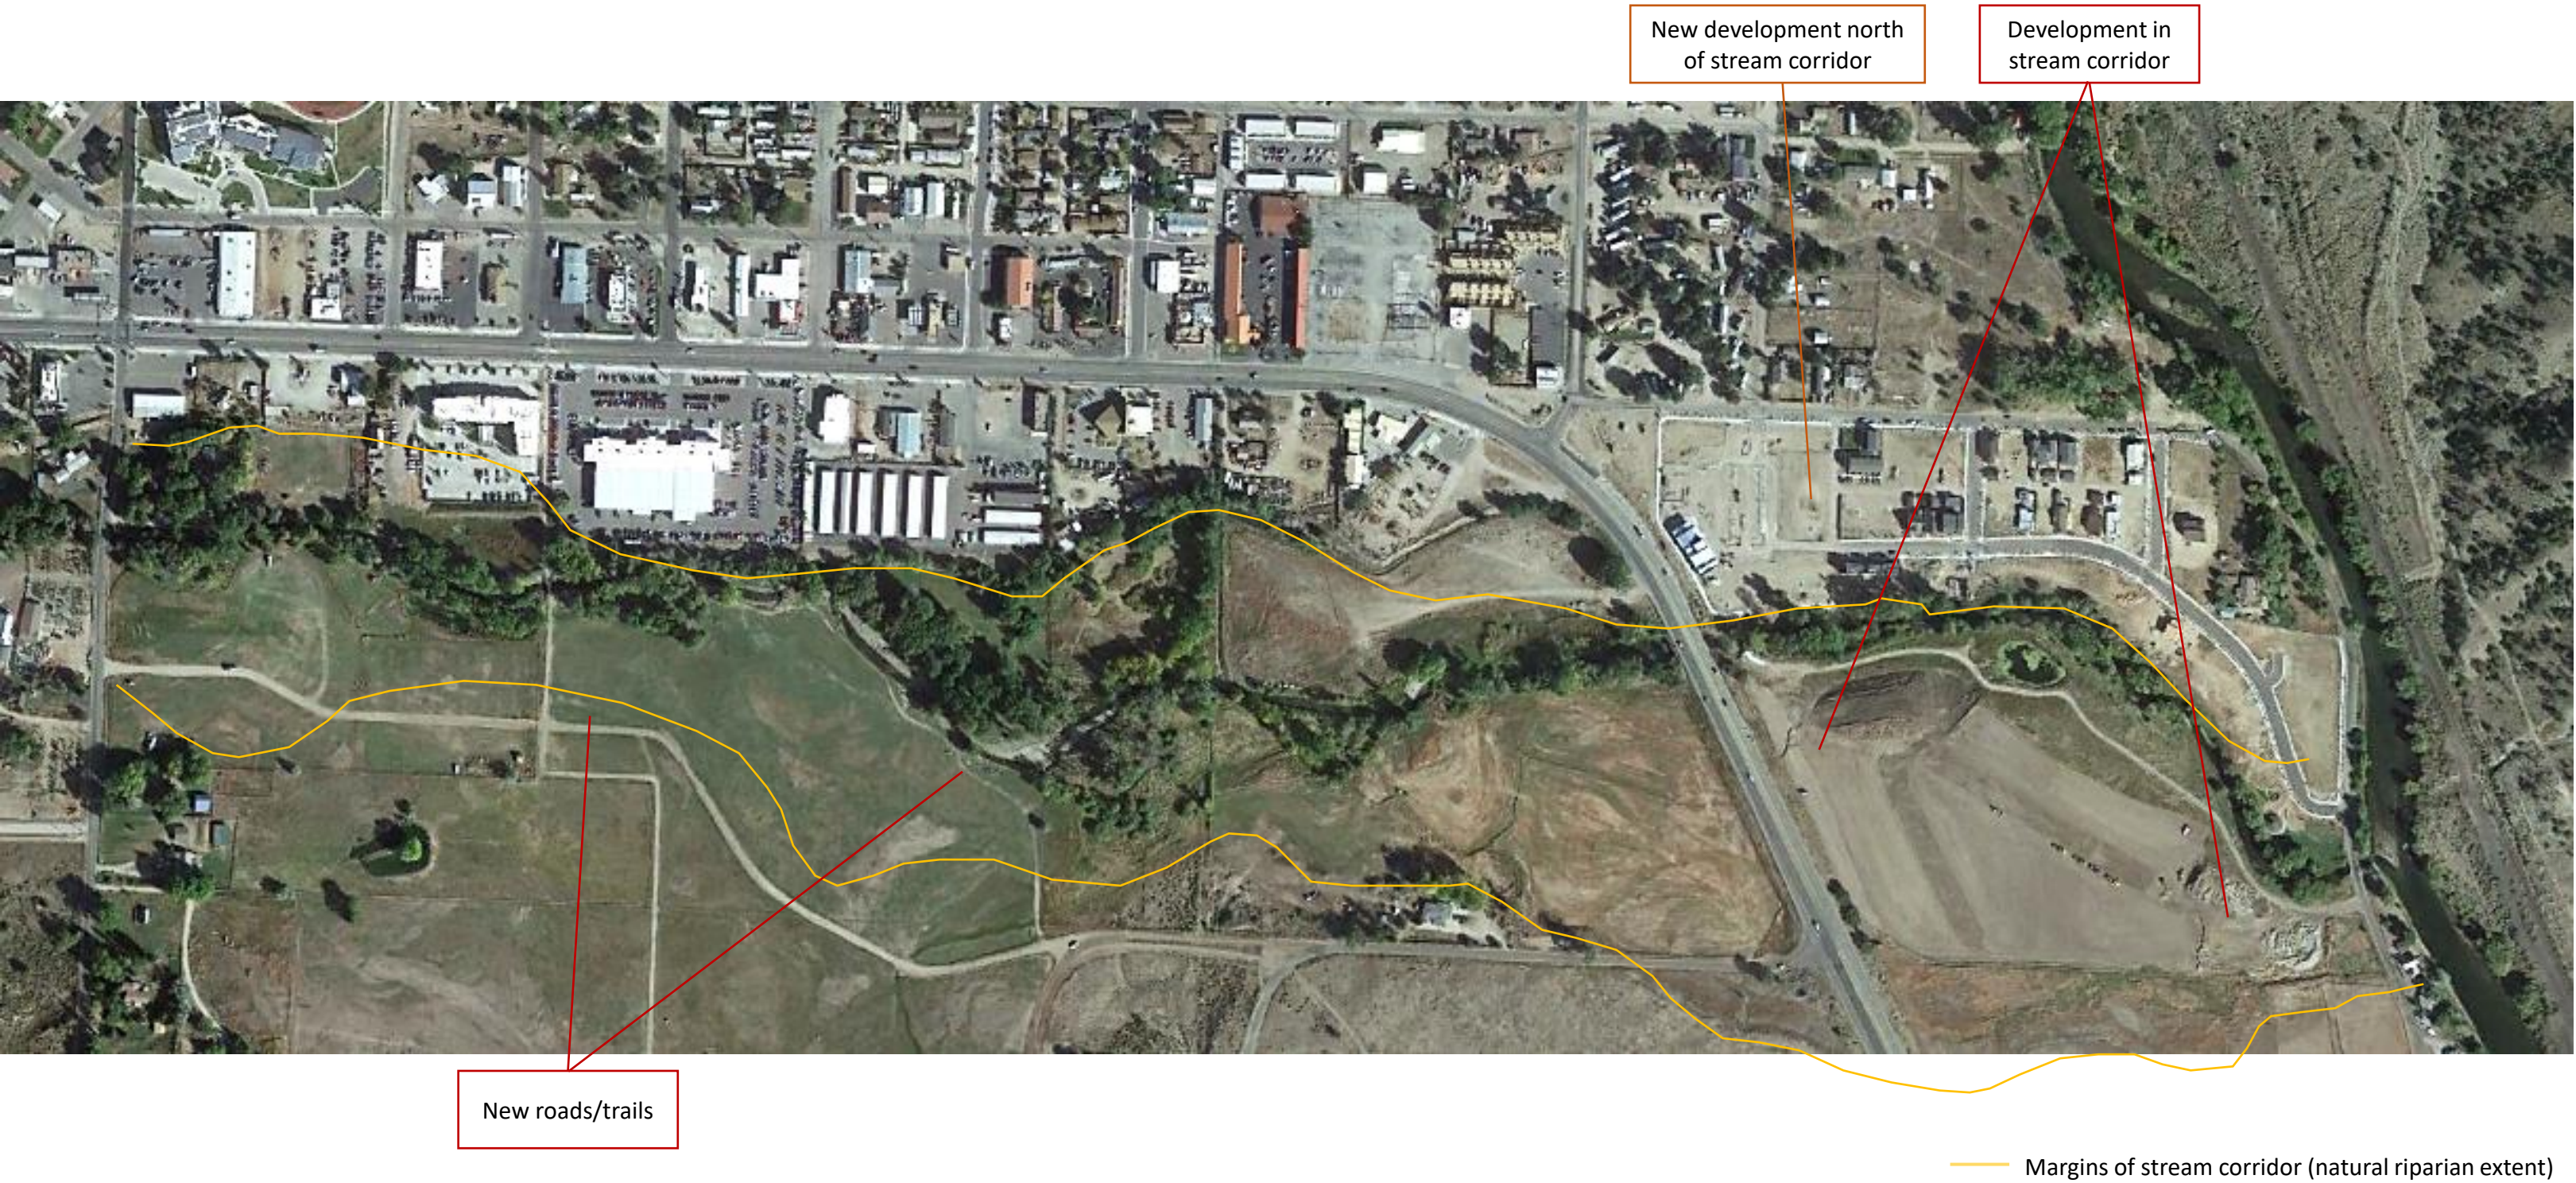
# 2019

In 2019, construction of the Two Rivers housing development within and adjacent to the stream corridor was well underway. New roads and trails were constructed in and adjacent to the corridor upstream.
